## **ASBESTOS MANAGEMENT SURVEY REPORT**

**Howe Lane Farm/Stag Farm  
Howe Lane  
Binfield  
Bracknell.  
RG42 5QS**

**27th February 2025**

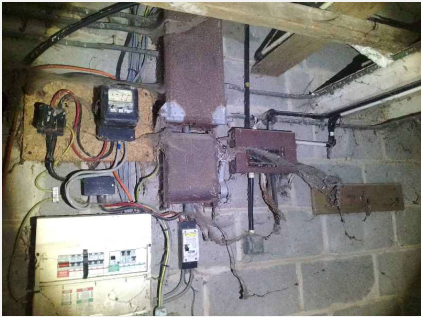
1	No sample taken	Ground Floor	Main site Switchroom 002				3 no.	
ID	Material Description		Product Type				Asbestos Type	
PTCA	No access gained within rusted electrical switchgear due to live status		N/A				Presumed	
Accessibility	Product Type	Extent of Damage	Surface Treatment	Asbestos Type	Total	Priority	Recommendation	Comments
N/A	N/A	N/A	N/A	N/A	N/A	N/A	Exercise Caution	Presumed chrysotile

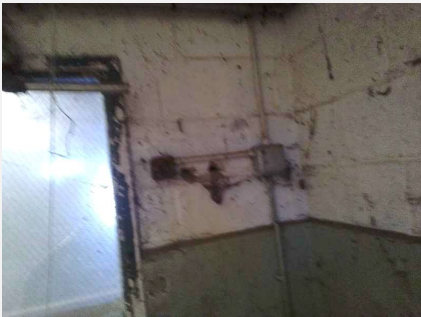
2	No sample taken	Ground Floor	Main site Store 003				1 no.	
ID	Material Description		Product Type				Asbestos Type	
PTCA	No access gained within Bill electrics due to live status		N/A				Presumed	
Accessibility	Product Type	Extent of Damage	Surface Treatment	Asbestos Type	Total	Priority	Recommendation	Comments
N/A	N/A	N/A	N/A	N/A	N/A	N/A	Exercise Caution	Presumed chrysotile

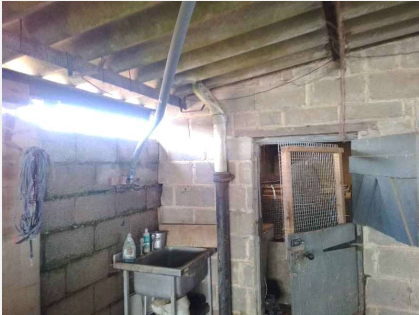
3	GF004409	Ground Floor	Main site Open area 008				1.5 lm	
ID	Material Description		Product Type				Asbestos Type	
AD	Cement downpipe		Cement Moulded Products				Chrysotile	
Accessibility	Product Type	Extent of Damage	Surface Treatment	Asbestos Type	Total	Priority	Recommendation	Comments
Occasionally likely to be disturbed	1	1	1	1	4	Low	Monitor Condition

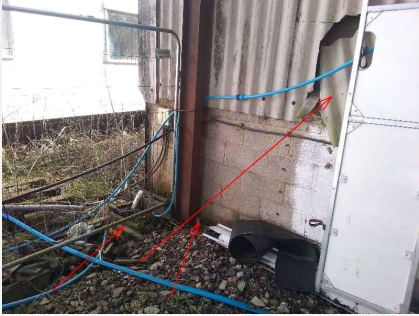
4	GF004410	Ground Floor	Main site Open area 4 011				2 m²	
ID	Material Description		Product Type				Asbestos Type	
AD	Cement debris to walls and floor adjacent open area 3		Cement Profiled Sheet				Chrysotile	
Accessibility	Product Type	Extent of Damage	Surface Treatment	Asbestos Type	Total	Priority	Recommendation	Comments
Easily disturbed	1	3	1	1	6	Low	Remove

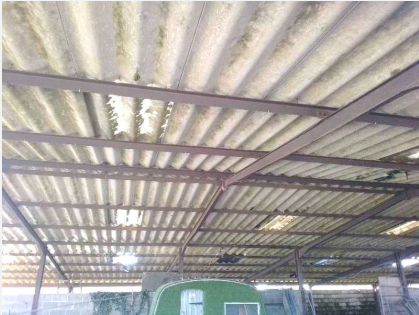
5	GF004411	External	Main site External areas E01				1200 m²	
ID	Material Description		Product Type				Asbestos Type	
AD	Large grooved cement profiled roof sheets		Cement Profiled Sheet				Chrysotile	
Accessibility	Product Type	Extent of Damage	Surface Treatment	Asbestos Type	Total	Priority	Recommendation	Comments
Usually inaccessible or unlikely to be disturbed	1	1	1	1	4	Low	Monitor Condition

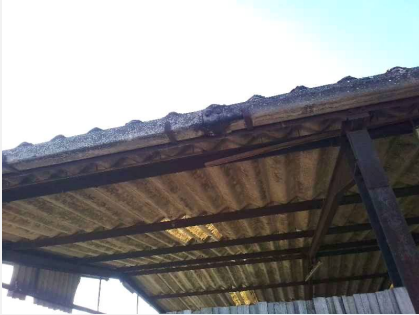
6	GF004412	External	Main site External areas E01				80 m²	
ID	Material Description		Product Type				Asbestos Type	
AD	Small grooved cement profiled roof sheets		Cement Profiled Sheet				Chrysotile	
Accessibility	Product Type	Extent of Damage	Surface Treatment	Asbestos Type	Total	Priority	Recommendation	Comments
Usually inaccessible or unlikely to be disturbed	1	1	1	1	4	Low	Monitor Condition

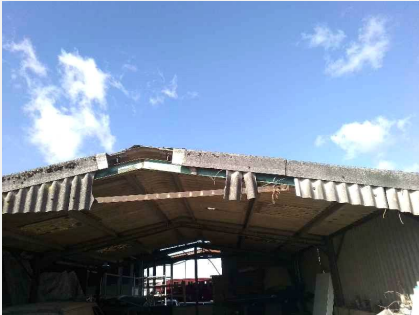
7	GF004413	External	Main site External areas E01				40 m²	
ID	Material Description		Product Type				Asbestos Type	
AD	Cement profiled wall sheets		Cement Profiled Sheet				Chrysotile	
Accessibility	Product Type	Extent of Damage	Surface Treatment	Asbestos Type	Total	Priority	Recommendation	Comments
Usually inaccessible or unlikely to be disturbed	1	2	1	1	5	Low	Monitor Condition

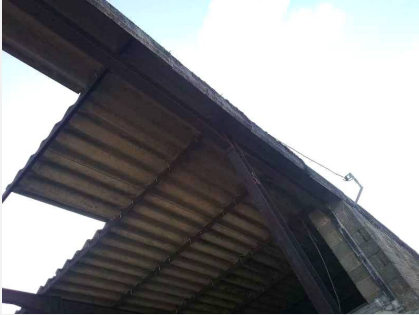
8	GF004414	External	Main site External areas E01				50 lm	
ID	Material Description		Product Type				Asbestos Type	
AD	Cement barge boards to large grooved profiled roof sheets		Cement Moulded Products				Chrysotile	
Accessibility	Product Type	Extent of Damage	Surface Treatment	Asbestos Type	Total	Priority	Recommendation	Comments
Usually inaccessible or unlikely to be disturbed	1	1	1	1	4	Low	Monitor Condition

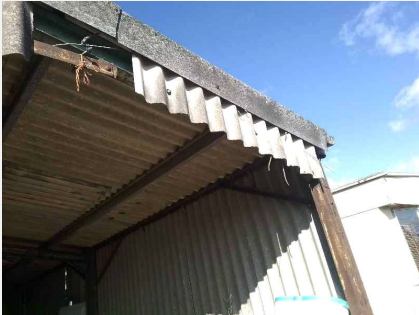
9	GF004415	External	Main site External areas E01				12 lm	
ID	Material Description		Product Type				Asbestos Type	
AD	Barge boards to open area 3		Cement Moulded Products				Chrysotile	
Accessibility	Product Type	Extent of Damage	Surface Treatment	Asbestos Type	Total	Priority	Recommendation	Comments
Usually inaccessible or unlikely to be disturbed	1	1	1	1	4	Low	Monitor Condition

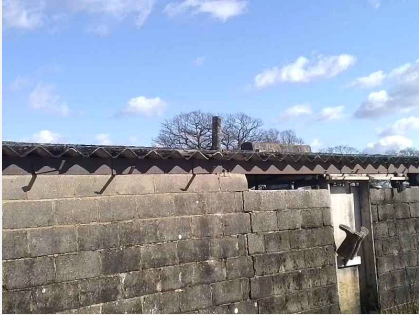
10	As GF004409	External	Main site External areas E01				0.5 lm	
ID	Material Description		Product Type				Asbestos Type	
SPTCA	Cement downpipe		Cement Moulded Products				Chrysotile	
Accessibility	Product Type	Extent of Damage	Surface Treatment	Asbestos Type	Total	Priority	Recommendation	Comments
Usually inaccessible or unlikely to be disturbed	1	1	1	1	4	Low	Monitor Condition

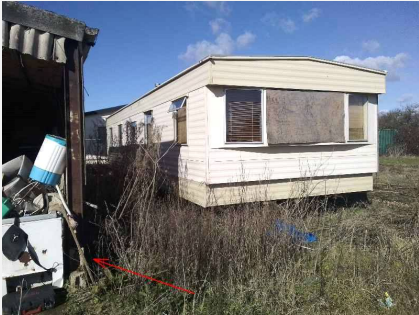
11	GF004416	External	Main site External areas E01				0.25 lm	
ID	Material Description		Product Type				Asbestos Type	
AD	Cement downpipe remnants adjacent open area 3		Cement Moulded Products				Chrysotile	
Accessibility	Product Type	Extent of Damage	Surface Treatment	Asbestos Type	Total	Priority	Recommendation	Comments
Occasionally likely to be disturbed	1	1	1	1	4	Low	Monitor Condition

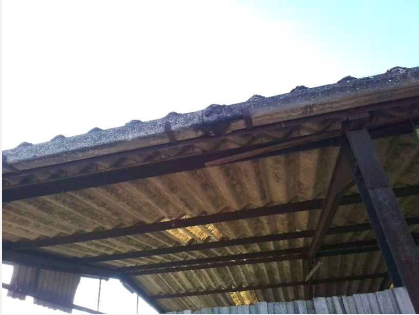
12	GF004417	External	Main site External areas E01				44 lm	
ID	Material Description		Product Type				Asbestos Type	
AD	Squared cement guttering to roof		Cement Moulded Products				Chrysotile	
Accessibility	Product Type	Extent of Damage	Surface Treatment	Asbestos Type	Total	Priority	Recommendation	Comments
Usually inaccessible or unlikely to be disturbed	1	1	1	1	4	Low	Monitor Condition

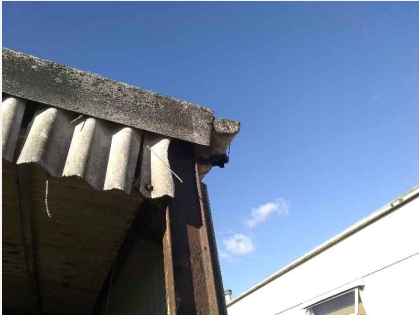
13	GF004418	External	Main site External areas E01				22 lm	
ID	Material Description		Product Type				Asbestos Type	
AD	Circular guttering to open area 3		Cement Moulded Products				Chrysotile	
Accessibility	Product Type	Extent of Damage	Surface Treatment	Asbestos Type	Total	Priority	Recommendation	Comments
Usually inaccessible or unlikely to be disturbed	1	1	1	1	4	Low	Monitor Condition

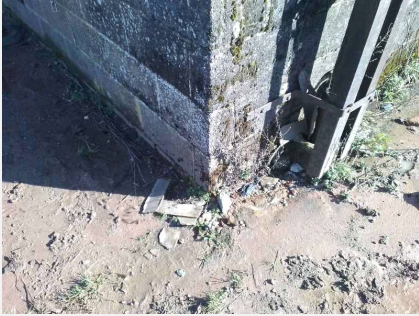
14	GF004419	External	Main site External areas E01				0.5 lm	
ID	Material Description		Product Type				Asbestos Type	
AD	Cement debris to front right hand side of building		Cement Profiled Sheet				Chrysotile	
Accessibility	Product Type	Extent of Damage	Surface Treatment	Asbestos Type	Total	Priority	Recommendation	Comments
Easily disturbed	1	3	1	1	6	Low	Remove

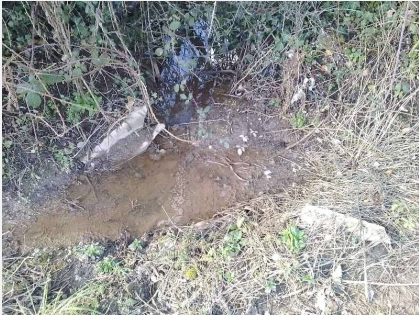
15	GF004420	External	Main site External areas E01				0.5 m²	
ID	Material Description		Product Type				Asbestos Type	
AD	Cement debris adjacent front gate		Cement Profiled Sheet				Chrysotile	
Accessibility	Product Type	Extent of Damage	Surface Treatment	Asbestos Type	Total	Priority	Recommendation	Comments
Occasionally likely to be disturbed	1	3	1	1	6	Low	Remove

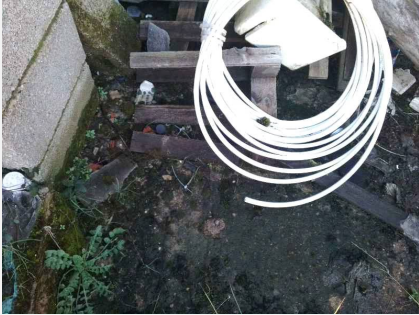
16	GF004421	External	Main site External areas E01				1 m	
ID	Material Description		Product Type				Asbestos Type	
AD	Cement debris adjacent open area 2 and 3		Cement Profiled Sheet				Chrysotile	
Accessibility	Product Type	Extent of Damage	Surface Treatment	Asbestos Type	Total	Priority	Recommendation	Comments
Occasionally likely to be disturbed	1	3	1	1	6	Low	Remove	Spread across 6m2 area

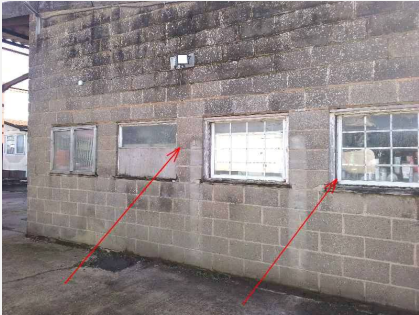
17	GF004422	External	Main site External areas E01				2 lm	
ID	Material Description		Product Type				Asbestos Type	
AD	Putty to front windows		Putty				Chrysotile	
Accessibility	Product Type	Extent of Damage	Surface Treatment	Asbestos Type	Total	Priority	Recommendation	Comments
Usually inaccessible or unlikely to be disturbed	1	1	0	1	3	Low	Monitor Condition	2 Windows as marked on photo

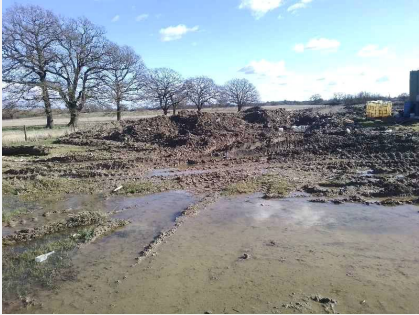
18	No sample taken	External	Main site External areas E01				Throughout	
ID	Material Description		Product Type				Asbestos Type	
PTCA	Sampling of soils was excluded from the scope of this Asbestos Management Report. We understand that this has been investigated by TRC Companies Limited as part of the ground investigation prepared under separate cover		N/A				Presumed	
Accessibility	Product Type	Extent of Damage	Surface Treatment	Asbestos Type	Total	Priority	Recommendation	Comments
N/A	N/A	N/A	N/A	N/A	N/A	N/A	Exercise Caution	Presumed amosite.

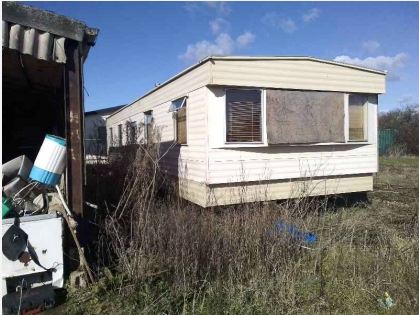
19	No sample taken	External	Main site External areas E01				2 no.	
ID	Material Description		Product Type				Asbestos Type	
PTCA	Caravan and park home excluded from the scope of the survey due to continued occupation		N/A				Presumed	
Accessibility	Product Type	Extent of Damage	Surface Treatment	Asbestos Type	Total	Priority	Recommendation	Comments
N/A	N/A	N/A	N/A	N/A	N/A	N/A	Exercise Caution	At the request of Paul Nixon
