ENVIRONMENTAL DUE DILIGENCE REPORT

The Crescent, Viables Business Park, Jays Close, Basingstoke RG22 4BS

Singer Vielle LLP

January 2026

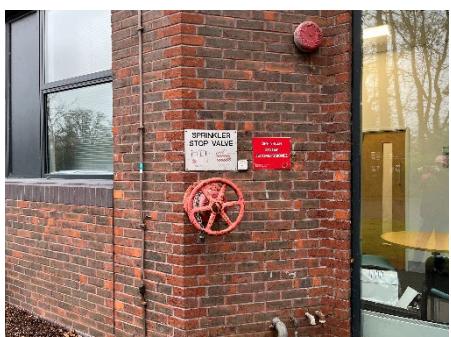
Photo 6: View of sprinkler cutoff valve (decommissioned) on eastern elevation

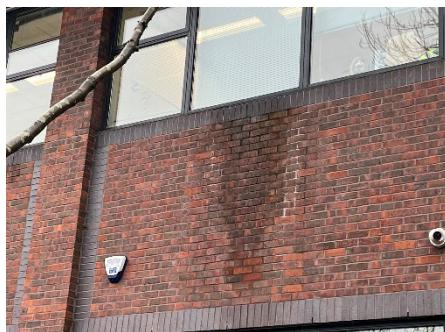
Photo 7: View of water damaged brickwork on northern elevation

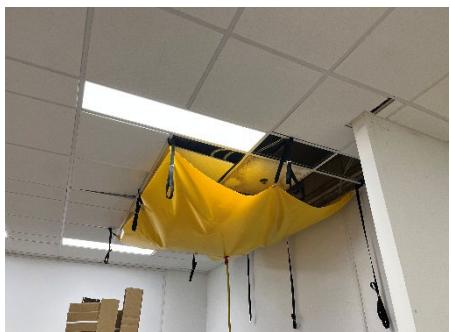
During our site inspection, no evidence of contamination and/or hazardous process was noted. However, there appeared to be a water leak within the assembly area and temporary sheeting had been placed by the tenant to protect the interior of the unit. The tenant has provided no further information on this.

Photo 9: View of water leak within assembly (tenant temporary repair)

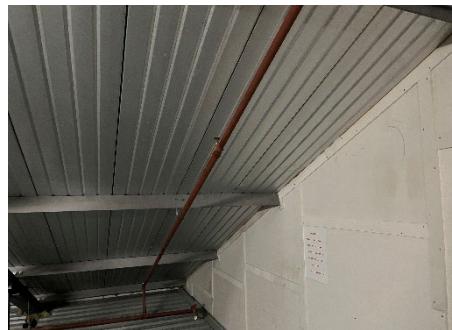
Photo 18: View of decommissioned sprinkler pipework within roof void

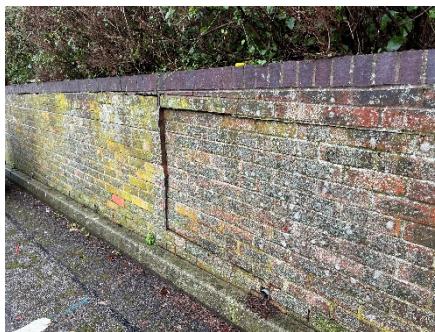
The site is secured by a combination of a low-rise brick wall along the southern boundary (with evidence of impact damage from vehicles) and galvanised steel palisade fencing on the eastern and northern boundaries. There are a number of mature trees around the boundary that provide screening between the site and the adjacent residential dwellings.

Photo 29: View of vehicle impact damage to southern boundary wall

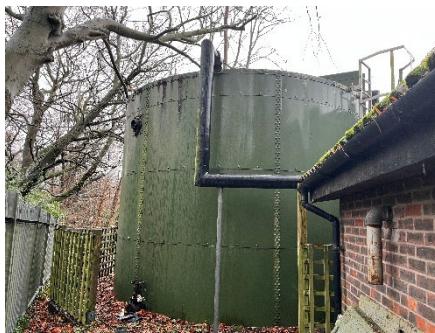
Photo 35: View of water sprinkler tank (installed 1987) understood to have been decommissioned

During our site inspection, we were informed that the fire sprinkler system that is fitted to Block A and B was decommissioned a number of years ago, but the sprinkler infrastructure (water tank, pipework and pump house) remain in place. We noted that the sprinkler system (pipe distribution network) had been removed from Block C as part of the 2025 refurbishment.

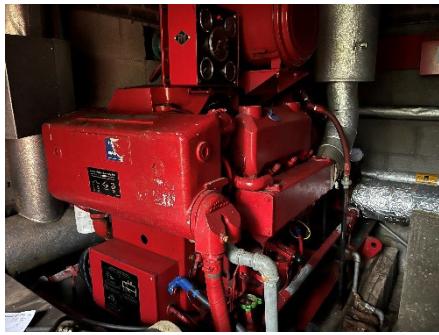
Photo 38: View of Cummins diesel powered generator (686 litre capacity) for the sprinkler pumps

Leaching to groundwater	Principal Aquifer	<p>There is the potential for surface impact of the concrete beneath the diesel-powered back-up generator.</p> <p>However, on inspection, no significant leakage/spillage of fuel was noted.</p> <p>CONNIX have not been provided with any ground investigation data to confirm the presence/absence of contamination.</p>	L
	Migration in groundwater	Water Abstractions	<p>No groundwater abstractions have been identified locally to the site.</p> <p>The underlying Seaford Chalk Formation is an important source of potable water and is potentially vulnerable to contamination.</p> <p>However, the overlying superficial deposits are expected to be relatively low permeability, mitigating the recharging of the more permeable bedrock strata below.</p>	L

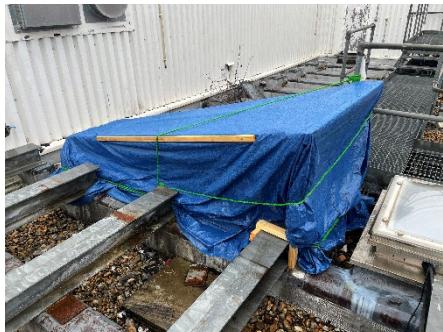
Photo 44: View of temporary repair to prevent water ingress through skylight on roof of Block B

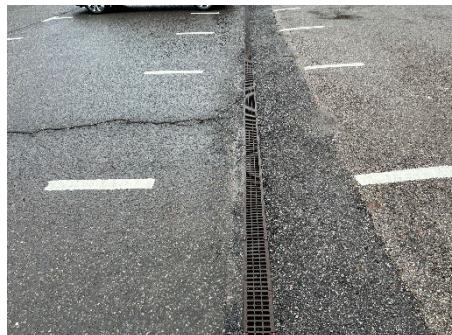
Photo 49: View of surface water drainage in front car park

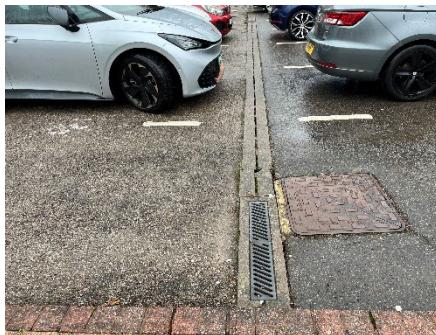
Photo 50: View of surface water drainage in front car park

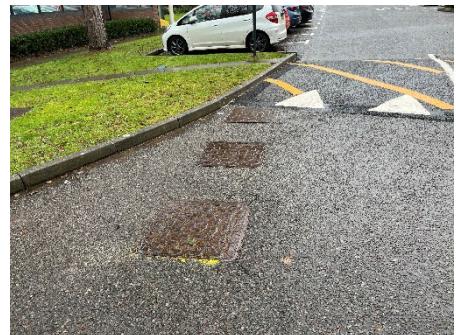
Within the car parks, there are a series of channel/ACO drains that appeared to be clear of significant quantities of vegetation and are understood to function adequately. We also noted 3no. inspection covers on southwestern corner

of Block A that may indicate the potential presence of an oil/water interceptor chamber assumed to connect to the surface water network.

Photo 51: View of possible interceptor inspection covers on southwestern corner of Block A

No site drainage plan is available for the site, but we have assumed that both surface and foul drainage connect to the public sewer. However, from our inspection we noted the presence of possible interceptor inspection covers on southwestern corner of Block A. This will help prevent any fuels/oils for the car park areas entering the surface water drainage system.

Should you wish to confirm the condition and/or the potential for misconnection of drains on site, there would be a need to undertake a CCTV drainage survey, and this may require pre-cleaning ahead of the survey.

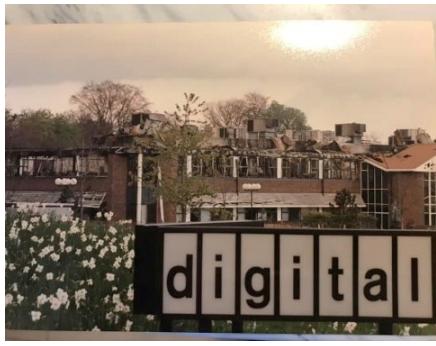
From an internet search^{1 2} we understand that in March 1990, a major fire broke out in the roof area of Digital Equipment Corporation's (DEC) headquarters known as 'The Crescent' in Basingstoke. Local news footage from the time shows the building to be significantly damaged.

We further understand from the former DEC Property and Facilities Manager that the main elements of the building survived and were subsequently repaired, but the roof was destroyed and was completely rebuilt.

Photo 53: View of building sometime after the fire in 1990

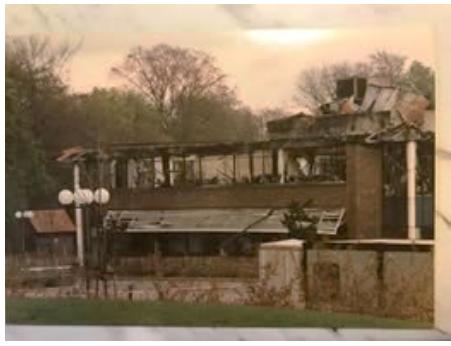
Photo 54: View of building sometime after the fire in 1990
