# VALIDATION REPORT

**63 SANDYCOMBE ROAD, RICHMOND,  
GREATER LONDON TW9 2EP**

**WOODCROFT DEVELOPMENTS**

**23/11527/B/KJC**

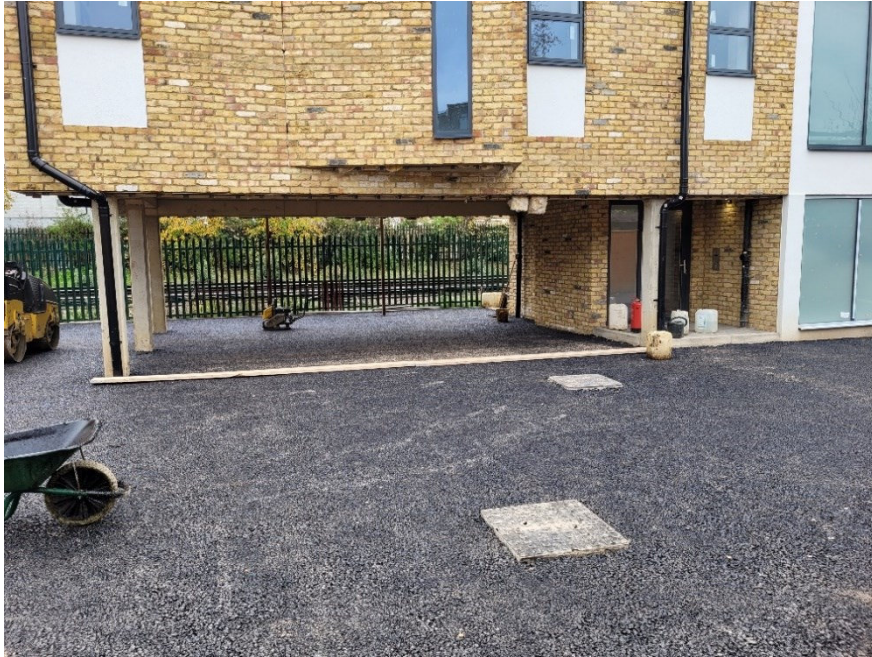
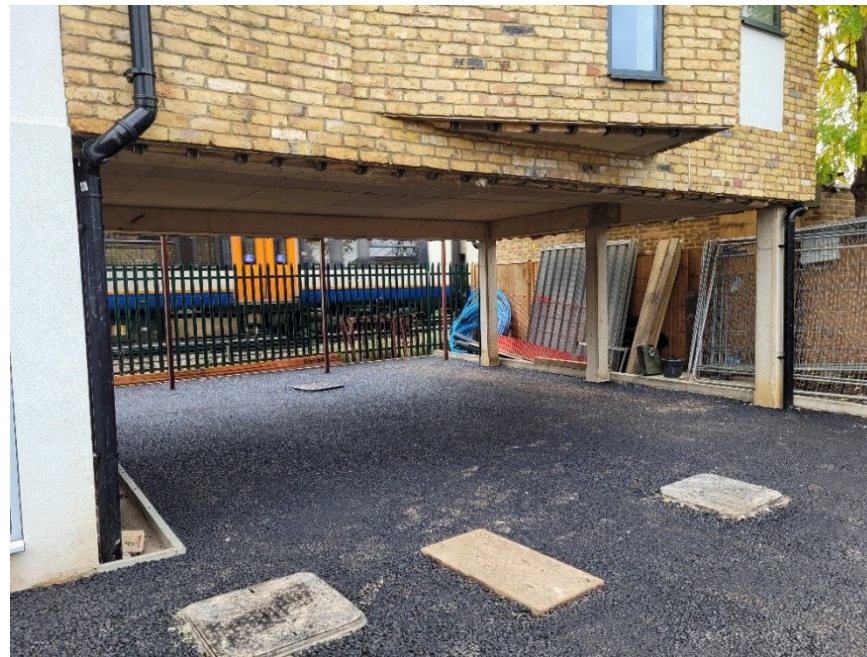
**FIGURE 2**

The Client has provided photographs of the areas of installed hardcover and the single area of proposed soft landscaping pre-remediation. These are included in Figures 2 and 3, respectively.

**PHOTOGRAPHS - HARD COVER**

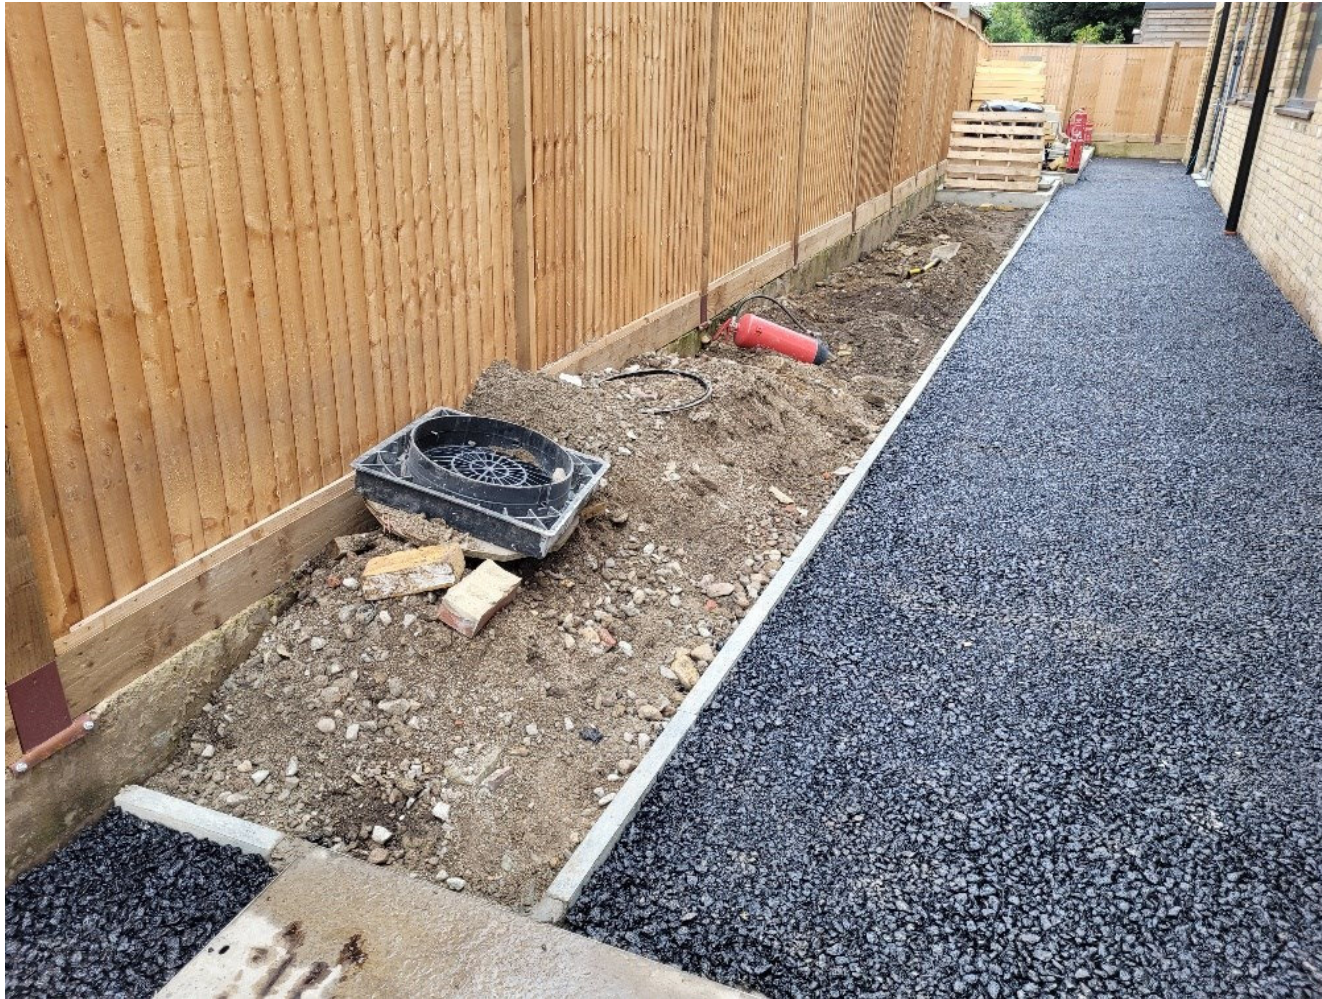
**FIGURE 3**

**PHOTOGRAPH - PRE-REMEDIATION**

Based on the findings and conclusions of the earlier report it was proposed within soft landscaping areas to remove 600mm of soil to be replaced with a cover of clean topsoil and subsoil. It should be noted that these measures are not necessary beneath permanent hardstanding or buildings.

A total thickness of clean cover of 600mm should be incorporated within areas of soft landscaping. The impacted soils should be excavated to a depth of 600mm below formation level and a hi-visibility geotextile placed at the base. The excavated soils should then be replaced with 450mm of inert, clean (non-waste), subsoil and an upper layer comprising certified topsoil of 150mm thickness to act as a growing medium.

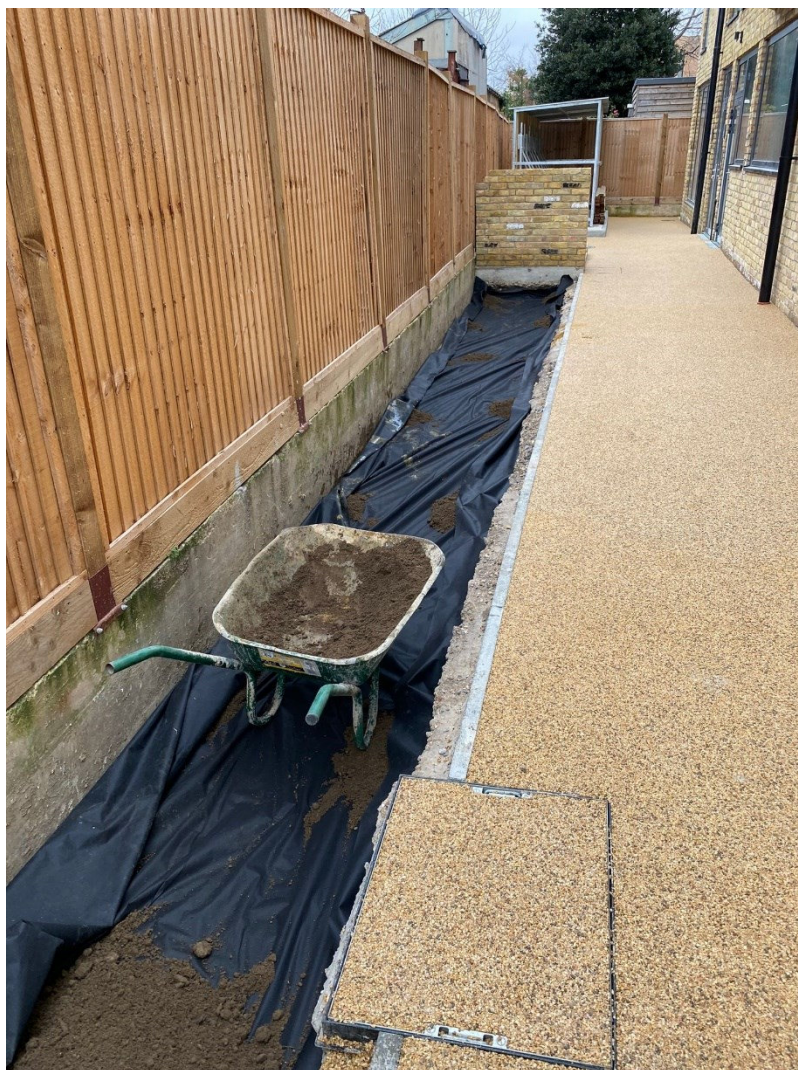
**FIGURE 4**

A photograph of the excavated area with the required membrane has been provided by the Client, presented as Figure 4. It is evident that the soils in the remediation area of soft landscaping have been removed. The presence of the wheelbarrow gives a perspective of the depth of excavation deemed to be the required 600mm. No “muckaway” or off-site disposal tickets have been made available.

**PHOTOGRAPH - MEMBRANE**

The landscaped area has been infilled with topsoil supplied by H. Sivyver (Transport) Ltd to its full depth above the placed membrane. A delivery ticket has been provided for the topsoil, 17.4 tonnes of TRU GROW, which is included in Appendix 1. The Client has confirmed that the membrane was obtained from Travis Perkins and comprises 4TRADE Heavy Duty Landscape Fabric.

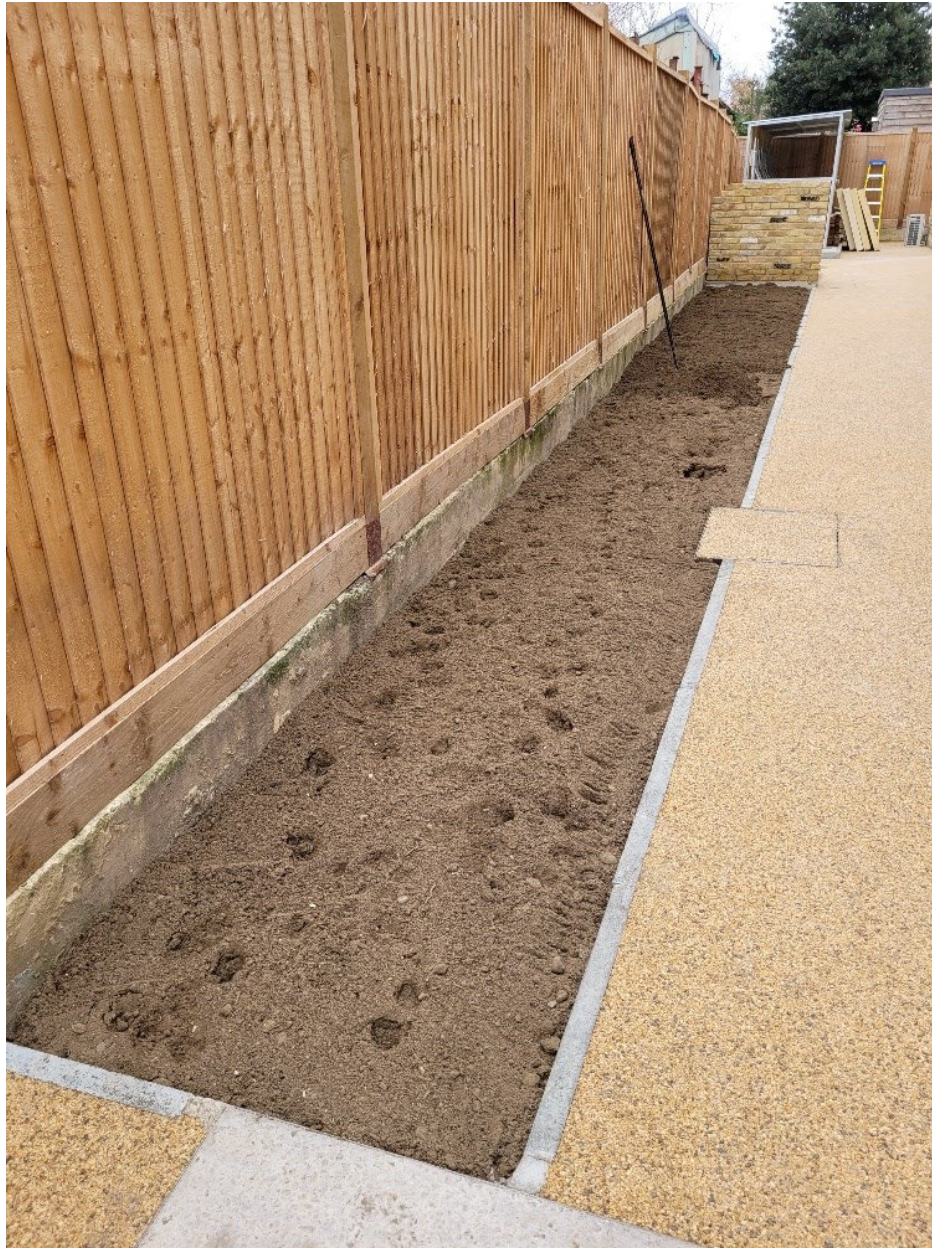
**FIGURE 5**

A topsoil analysis certificate has been supplied by the Client for the imported topsoil and forms Appendix 2. A photograph of the completed remediation is included as Figure 5.

**PHOTOGRAPH - POST-REMEDIATION**

It is considered that the information presented in the Appendices to this report confirms that the required remediation has been undertaken. The implementation of a cover system in areas of soft landscaping will break the dermal and ingestion exposure pathways between potential residual contamination and site receptors.
