ENVIRONMENTAL DUE DILIGENCE REPORT

The Crescent, Viables Business Park, Jays Close, Basingstoke RG22 4BS

Singer Vielle LLP

January 2026

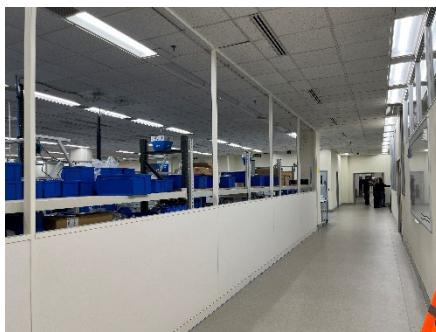
During our site inspection, no evidence of contamination and/or hazardous process was noted. However, there appeared to be a water leak within the assembly area and temporary sheeting had been placed by the tenant to protect the interior of the unit. The tenant has provided no further information on this.

Photo 8: View of assembly area (photography restricted in this area)

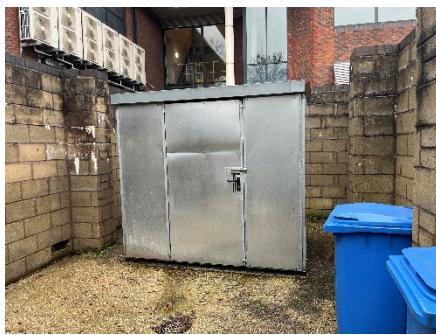
Photo 47: View of interior of waste compound – empty aluminium storage container present

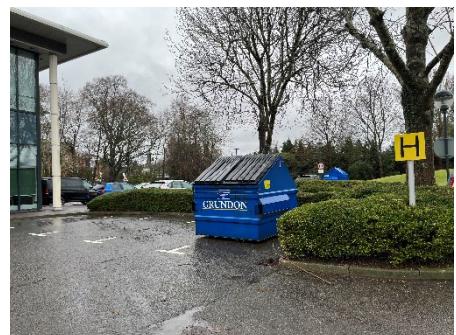
Photo 48: View of Grundon waste receptacles to south of Block B

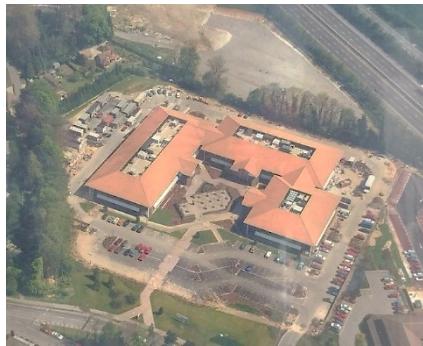
Photo 52: View of Building in c.1987 during final stage of 'original' construction
